*BALTICA* Volume 32 Number 1 July 2019: 10–21

## Tracking cliff activity based on multi-temporal digital terrain models – an example from the southern Baltic Sea coast

**Abstract.** A multi-temporal digital terrain models [DTM] study of a coastal cliff section at Kaszuby Coast (northern Poland) is presented in this paper. The analytical study was based on five LiDAR-derived DTM acquired between 2010 and 2016. The main idea was to compare changes year by year or every two years (depending on the available material). The DTM were analysed using various geoprocessing techniques, and as a result the map of slope and the gradient of maximum changes in z-value were prepared. The analysis of the temporal variations of these parameters were also prepared and allowed to visualize and track the landslides that occurred within the cliff. What is more, the areas of sediment increase and decrease, as well as the average rates of vertical displacement within the landslides and sediment balance on the beach were estimated. The studies allowed also to discuss the interrelation between the mass wasting processes and the protective infrastructure on the seashore. The information gathered allows us

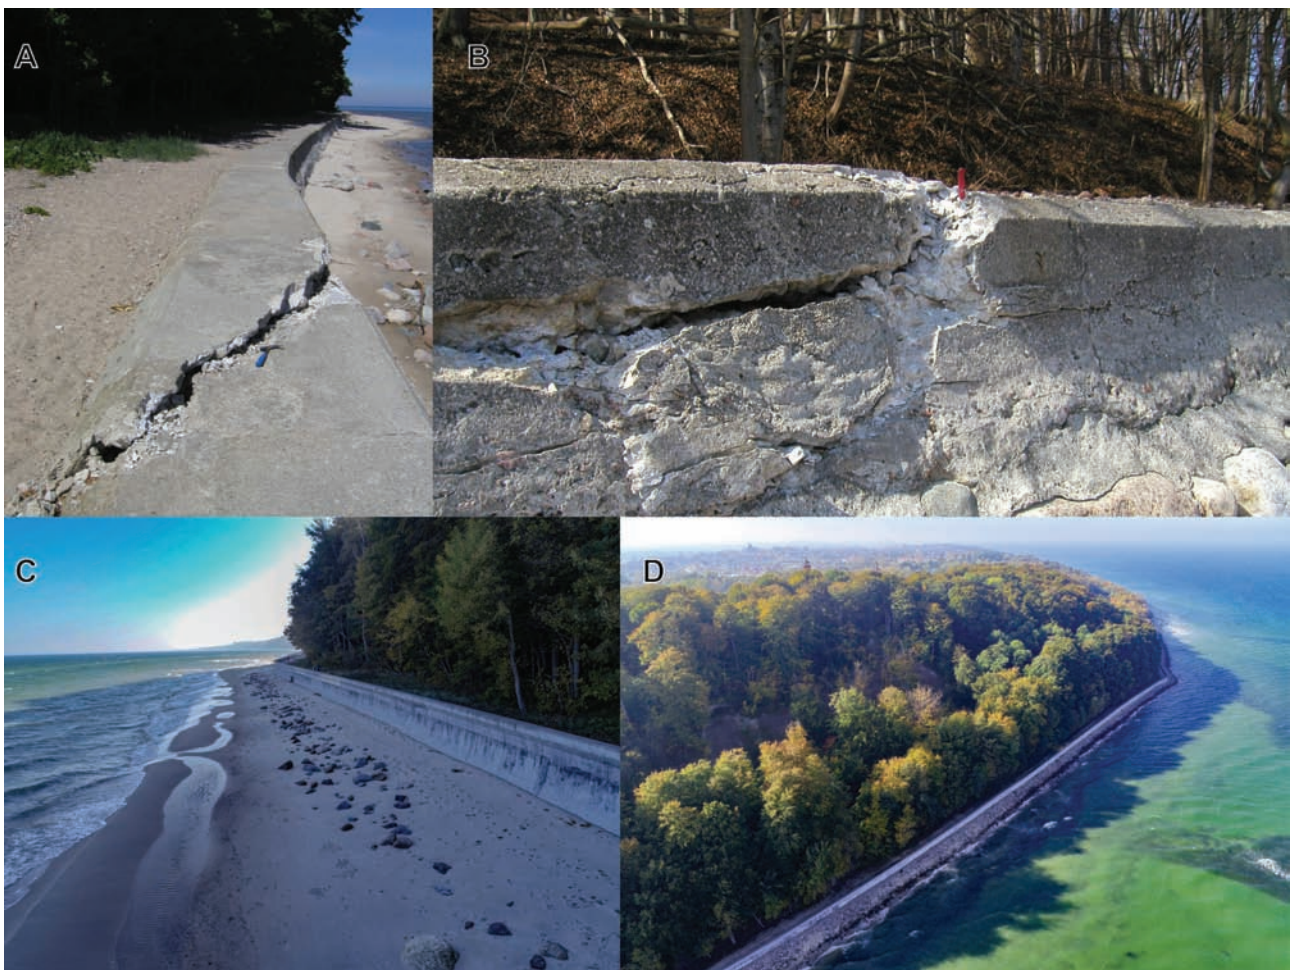
**Fig. 2** Damaged (A, B – photo: L. Jurys) and the rebuild and expanded (C, D – photo: M. Olkowicz) seawall at Rozewie headland

In 2013, the mentioned protective structure was expanded (Fig. 2 C, D). In 2012–2014, mass movements stopped and, at the same time, a slight marine

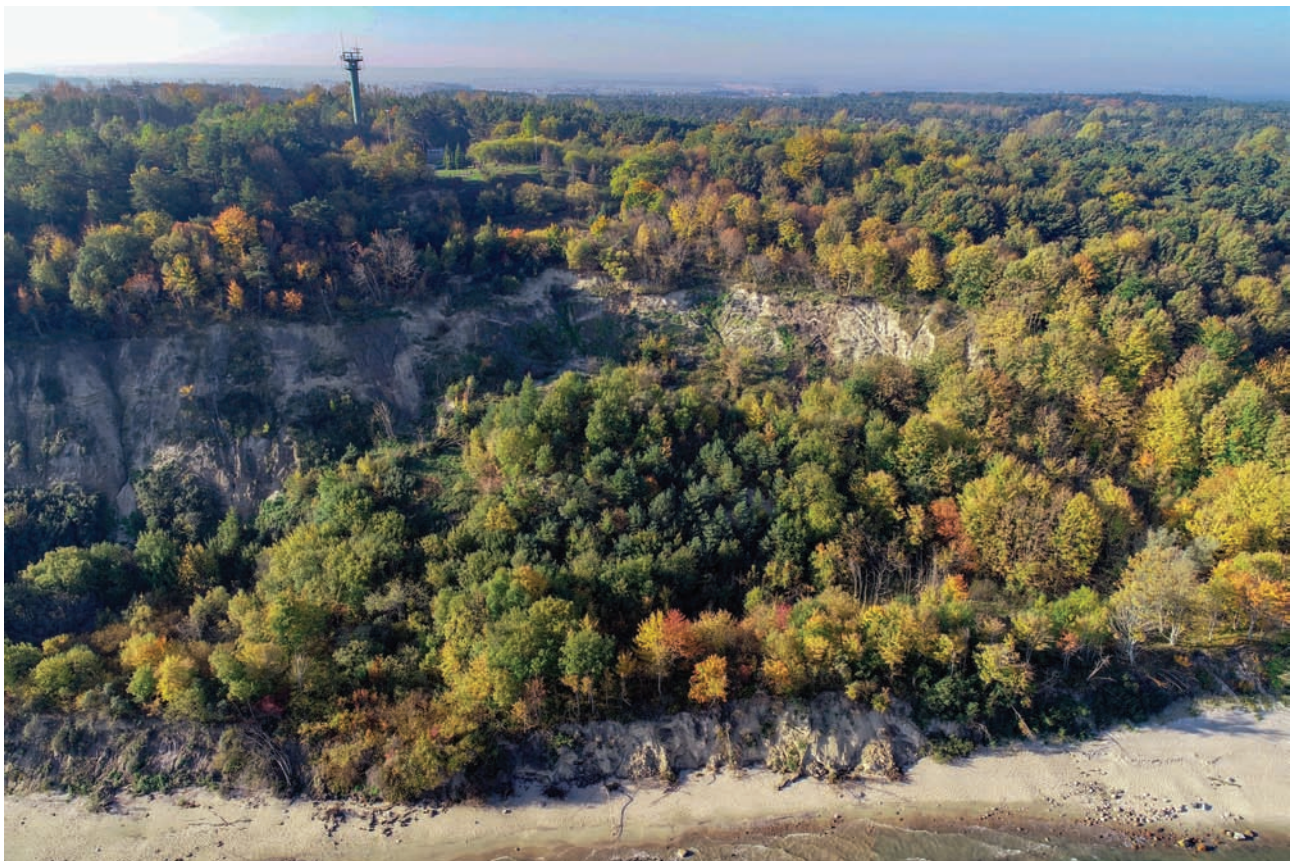
**Fig. 4** Chłapowo cliff section and the landslide (photo: M. Olkowicz)

A landslide at the Chłapowo cliff section (Fig. 4) is a large, complex landslide, both in terms of geological structure and mass wasting processes. The illustration for 2010–2012 differences shows that the landslide in terms of activity is bipartite. The SE part is definitely more active than NW part. This is also underlined by the course of landslide boundaries, especially within the main scarp, where the SE part is bent semicircularly and goes further into the land.

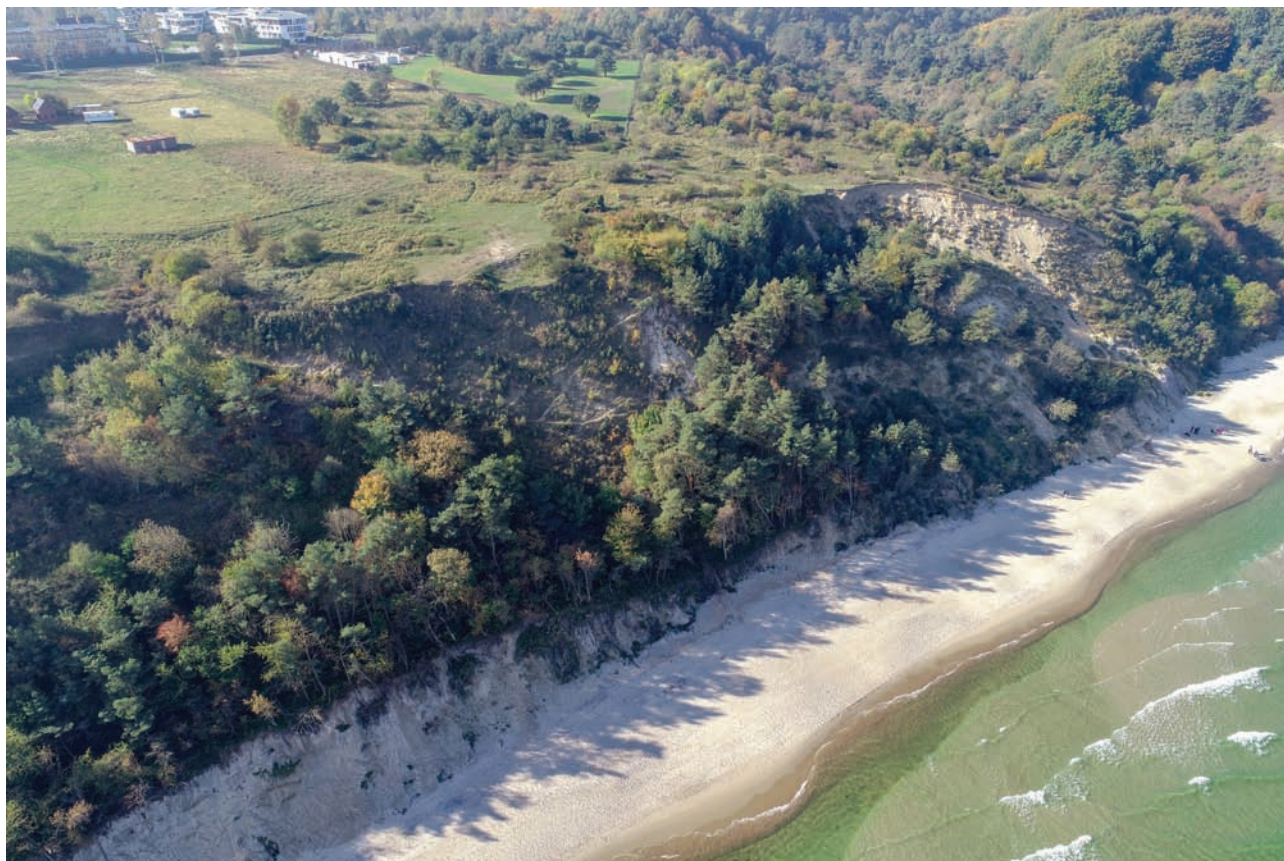
**Fig. 6** Landslides on the area of 128 km of Polish coast

Another characteristic feature of this part of the coast is a landslide complex in the area of 128 km of the Polish coast. This cliff section is almost entirely occupied by mass wasting processes. First of all, the domination of marine erosion is visible, which removes colluvial material deposited at the cliff foot (2010–2012). In the next analysed period (2012–2014), erosion still interacts but with less intensity and is limited to the beach. Landslide in the NW part of the described region (Fig. 6) is inactive while the other three show little activity from the cliff top to the foot.
