**Changes in Latvia's seacoast (1935-2007)**

**Guntis Eberhards, Ineta Grīne, Jānis Lapinskis, Ingus Purgalis, Baiba Saltupe, Aija Torklere**

Eberhards, G., Grīne, I., Lapinskis, J., Purgalis, I., Saltupe, B., Torklere, A. 2009. Changes in Latvia's seacoast (1935-2007). *Baltica*, Vol. 22 (1), 11-22. Vilnius. ISSN 0067-3064.

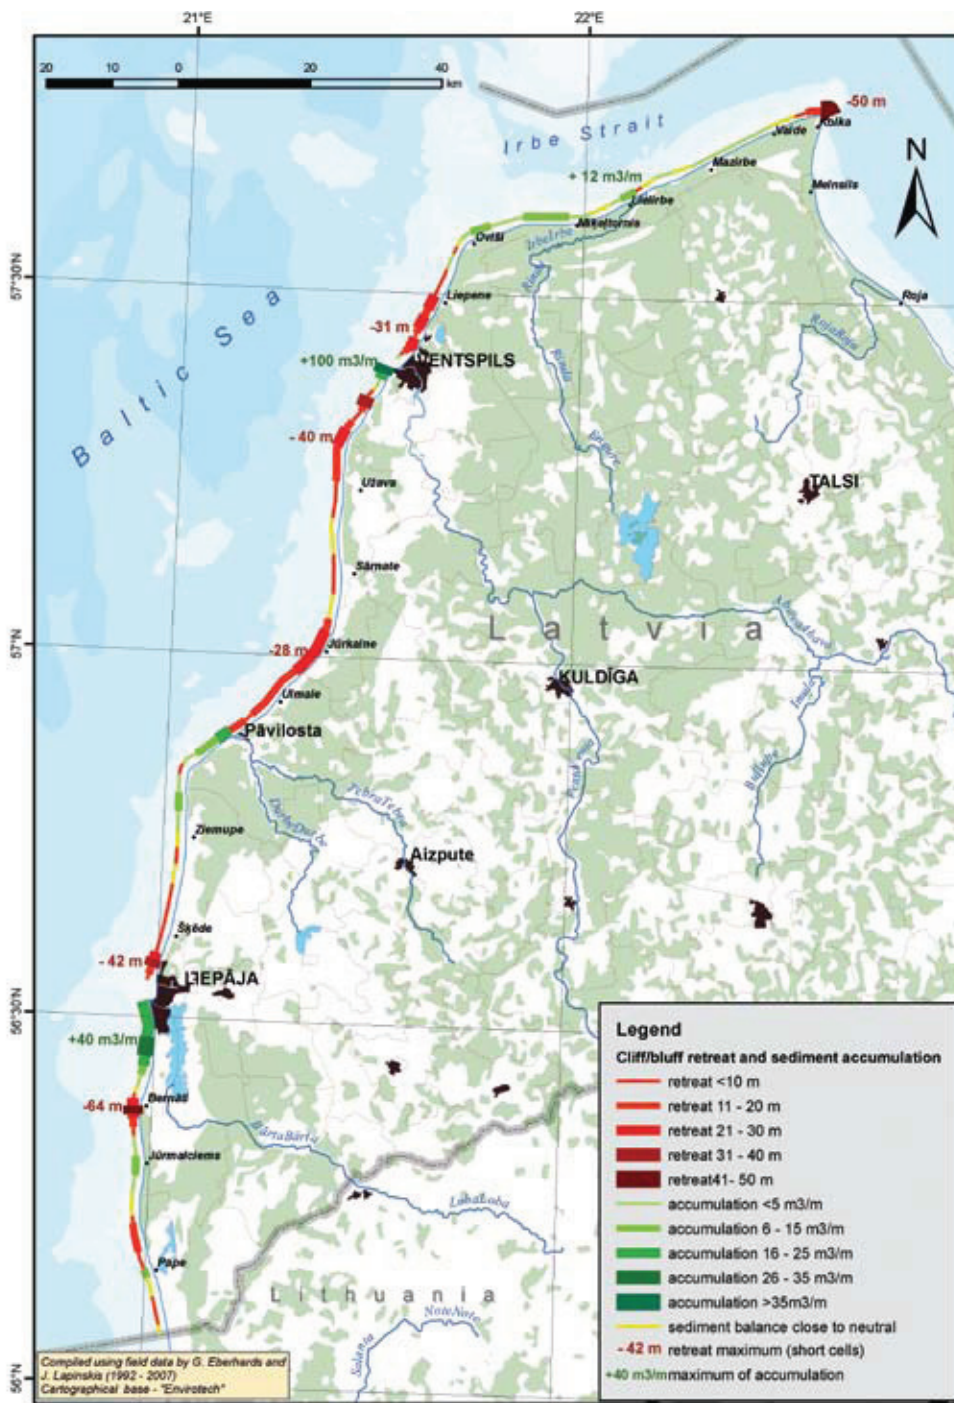
Fig. 4. Changes to the Kurzeme coast of the Baltic Proper during the past 15 years (1992–2007). Compiled by G. Eberhards and J. Lapinskis.

to 2007 inclusive, coastal erosion maps after the severest storms were made, and by measurements taken at monitoring stations, the extent of coastal erosion during the last 15 years was determined (Figs. 4, 5).

Baltic seacoast, as well as on the Gulf of Riga's coast, have been significantly different, compared to the activation of these processes during the past 15 years (1992–2007) (Figs. 2, 3, 4, and 5). These changes were primarily caused by the orientation of separate sections of coastline relative to wind directions during storms, the repetitiveness of storms, the direction of long-shore sediment drift, the strength and amount of sedimentary deposits in the shallow sea's lithodynamic zone, as well as the geological structure of the coast and the coastal valley resistance to wave erosion. In

Bernāti, Melnrags), as well as down drift the ports of Liepāja and Ventspils (Fig. 4). The erosion at the Cape of Kolka during the storms of 2001 and 2005 was especially catastrophic due to predominant W and NW winds (Eberhards 2003; Lapinskis 2006).

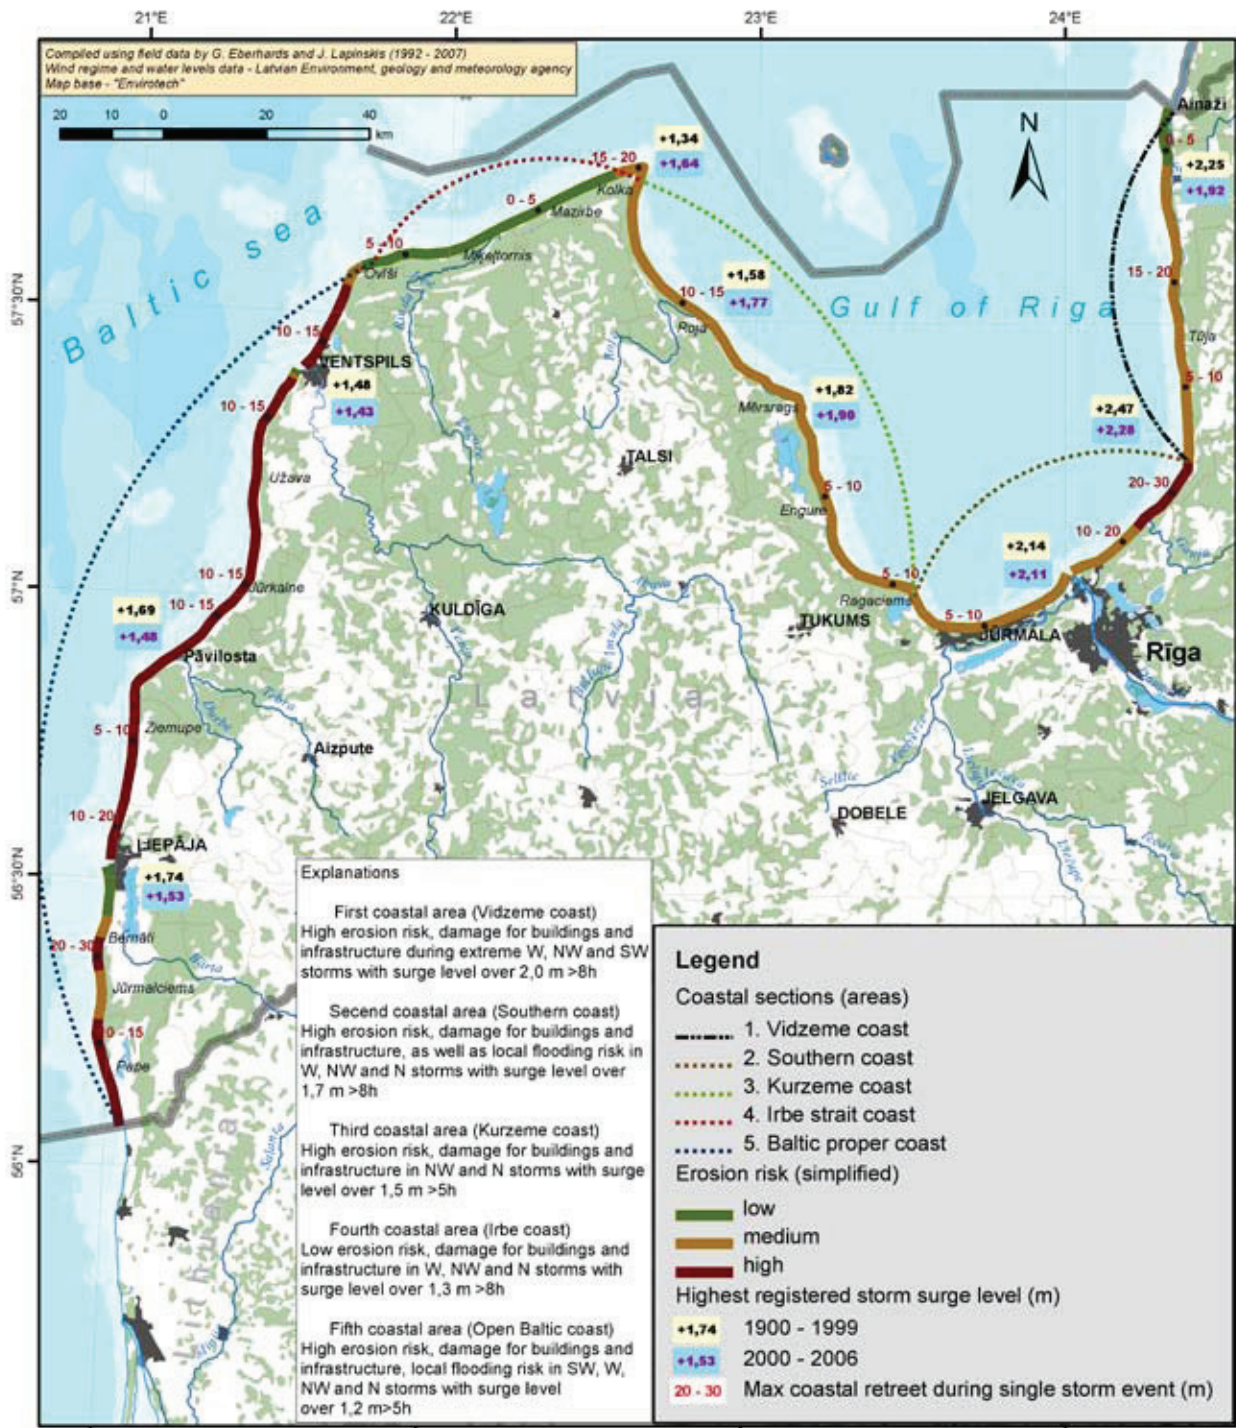
Fig. 8. Latvia's sea-coast zones with different erosional risk. Compiled by G. Eberhards and J. Lapinskis.

measurements of erosional intensity, and hydro-meteorological information during severe storms of the past ten years. According to the aforementioned factors, the Latvian coast was divided into five different coastal zones (Fig. 8). For NW storms, the most sensitive area threatened by damage to structures and infrastructure, high coastal erosion, and local flooding is the Kurzeme coast of the Gulf of Riga (Kolka – Jūrmala); the threat of damage to built-up residential areas is greatest along the open Baltic seacoast (Nida – Ovīšu cape); the greatest threat by coastal erosion and flooding is along the Gulf’s southern coast (Jūrmala – Saulkrasti). Stable and little threatened by erosion is the coast along the Irbe Strait, with the exception of the Cape of Kolka (from Vaide to Kolka). The eastern shore of the Gulf of Riga and the buildings along it are seriously threatened only during rare, extreme storms.
